Intel[®] Mobile Celeron[™] Processor Specification Update

Release Date: October 1999

Order Number: 244444-008

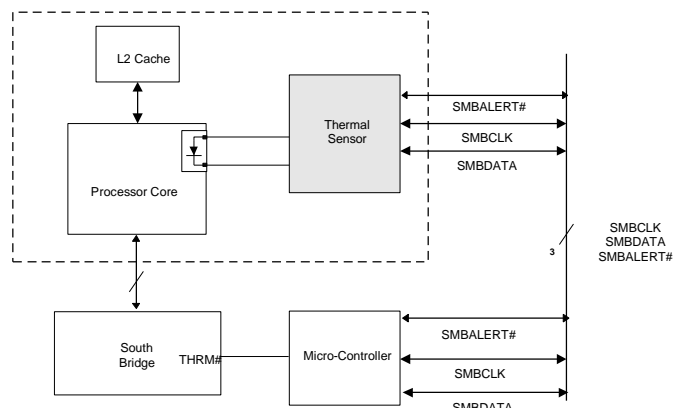
Figure 1. An Example of Microcontroller Driven Thermal Management

H29. Thermal Sensor May Assert SMBALERT# Incorrectly

Problem: The Intel Celeron Processor Mobile Module has a thermal sensor that monitors the processor core's temperature. Please note that desktop systems could have a similar thermal device. The thermal sensor asserts SMBALERT# if the processor temperature exceeds the temperature limits set in the Alarm Threshold Registers (T_{HIGH}, T_{LOW}). It also sets the corresponding Status Register bits to identify the cause of the interrupt. Figure 1 gives one example of the how the SMBALERT# signal could be used in a system.

Implication: There is no system impact from this erratum if temperature polling is used for processor thermal management. If the SMABLERT# interrupt is employed to manage processor thermal sensing, then servicing the false interrupt may result in premature system action depending on the software and hardware implementations used. The rate of the false interrupts is less than the auto-convert rate of the thermal sensor.

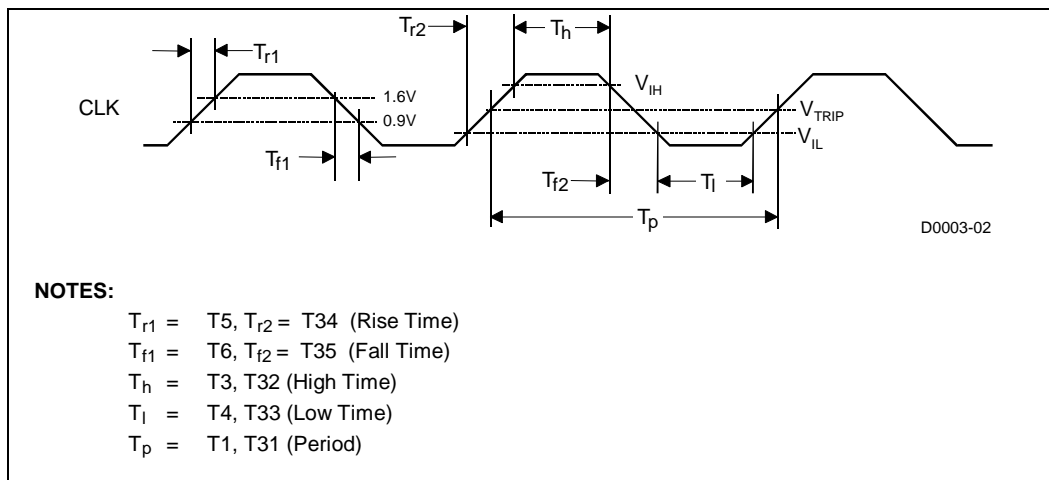
Figure 3.3 Generic Clock Waveform

H11. Generic Clock Waveform Figure

Figure 3.3 in the *Intel® Mobile Celeron™ Processor in mPGA1 and BGA1 Packages at 366 MHz, 333 MHz, 300 MHz, and 266 MHz* datasheet (Order Number 245112-003) has been updated. The following figure is to replace the one in the above document.
